## KS-20472 BELLCELL\* BATTERY VISUAL INSPECTION PROCEDURE

**SECTION 157-629-702**

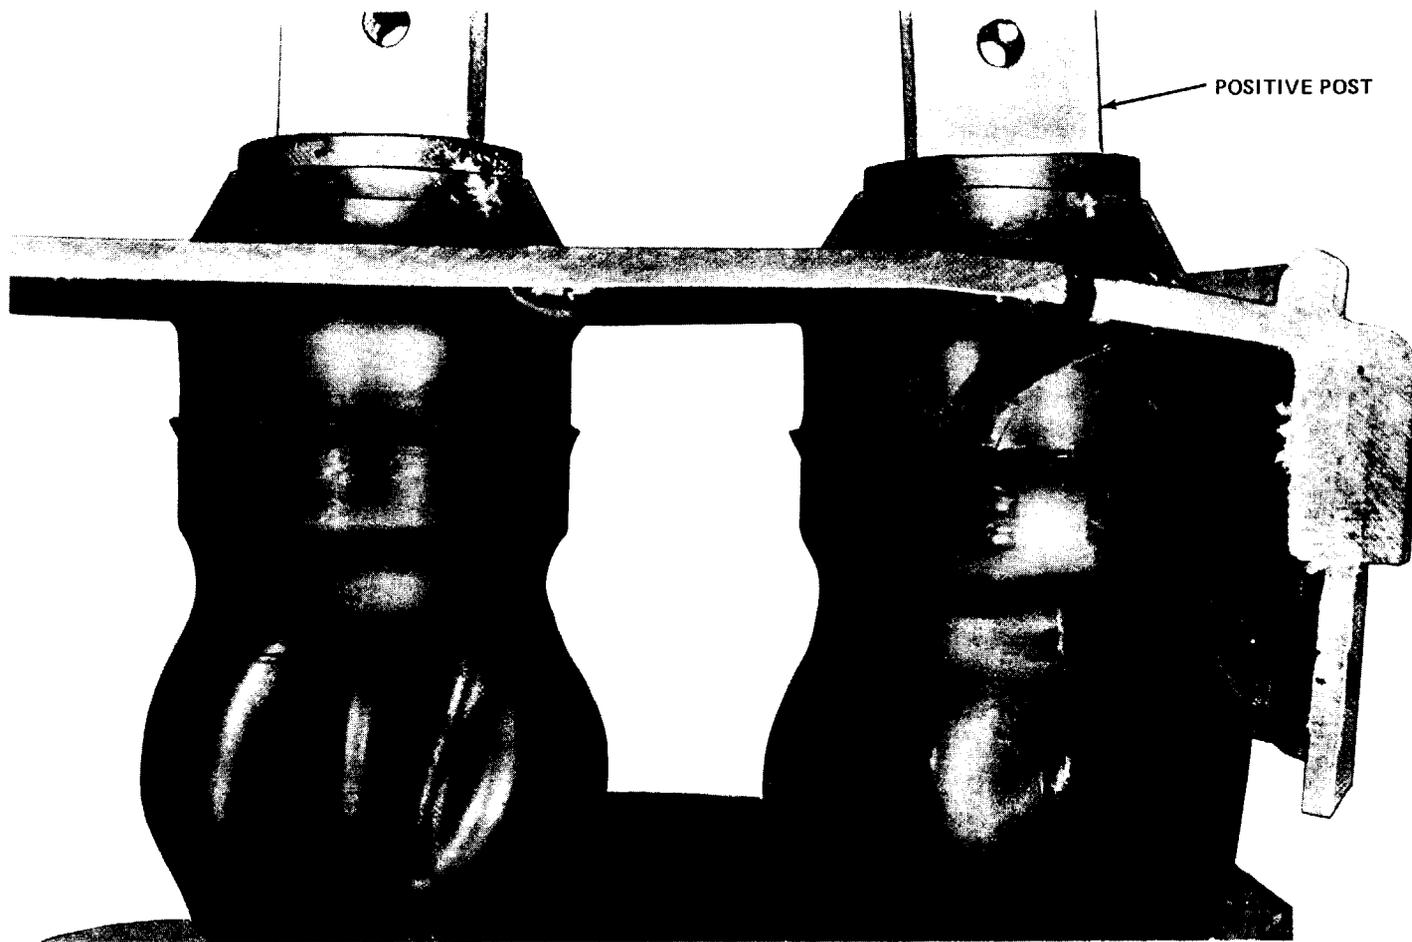
4.03 As the corrosion increases, broken particles and powder can start to fill up the boot. Techniques for assembling the post seals in manufacture are such that the boot section of the rubber sleeve will usually have depressions in it. These depressions are shown in Fig. 6. On positive posts, with severely defective seals, the accumulation of corrosion product expands the rubber boot such that the depressions disappear. This is shown in Fig. 7 where no depressions exist in the boot of the positive post seal. Depressions still exist in the negative post boot since corrosion does not occur on the negative post. Sometimes the boot section is inflated because of air pressure inside the boot. Accordingly, it is necessary to probe the boot with the tip of the hook in order to differentiate between corrosion and air. If air fills the boot, it will be flexible. If corrosion fills the boot, it will be hard and should not be lifted.

Fig. 7—Cell Posts Showing Swollen Boot Due to Post Corrosion

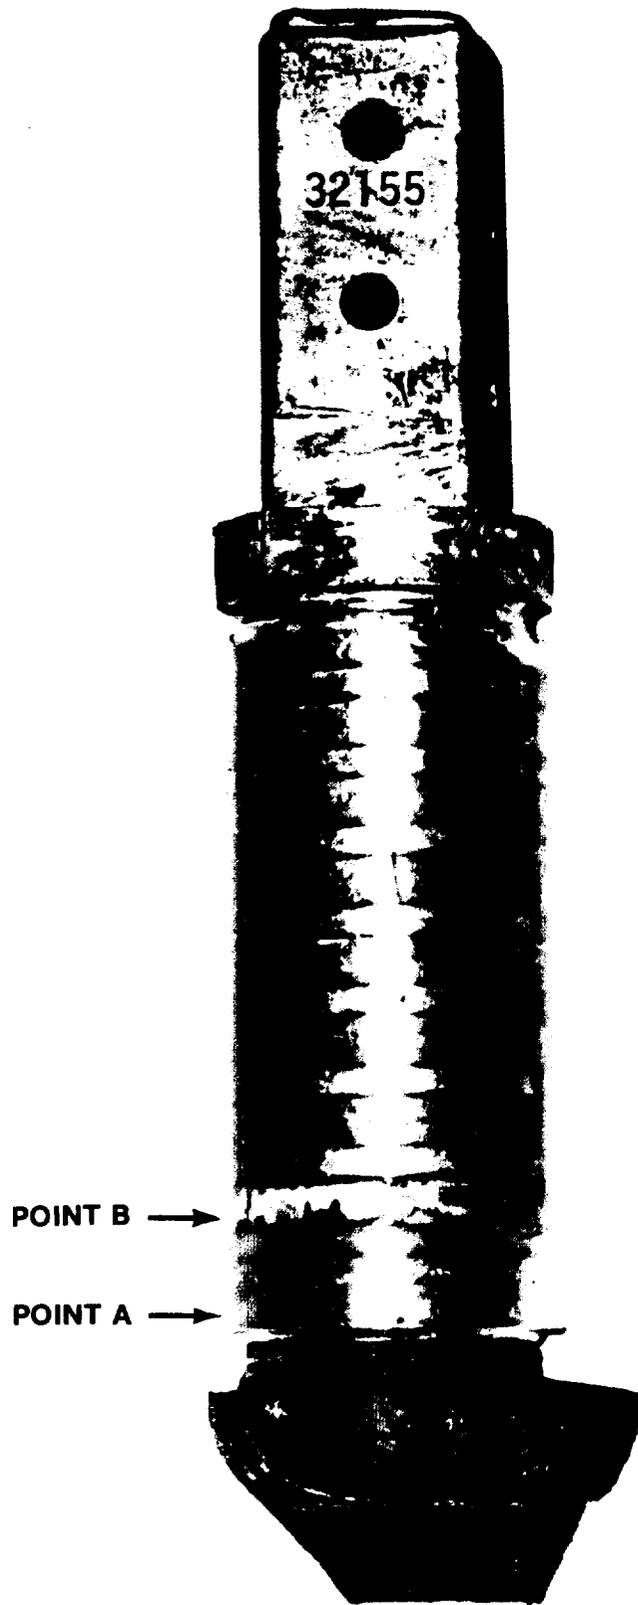
RATING	DESCRIPTION (SEE NOTE)	EXAMPLES
1	No visible corrosion	Fig. 8 Fig. 9, Point E
2	(a) Slight blisters or swelling visible on lead (less than 1/8-inch diameter)	Fig. 14, Point A

**8.06** The amber color of the epoxy shown in Fig. 8, Point A, and Fig. 9, above Point D is normal for this type of epoxy.

**8.07** The white and black areas under the epoxy shown in Fig. 8, Point B; and Fig. 10; Fig. 12, Point B; and Fig. 15, below Point C are the result of acid creepage up the epoxy/lead interface and are not indications of post corrosion.

Fig. 8—Rating 1—Normal Post (No Corrosion)

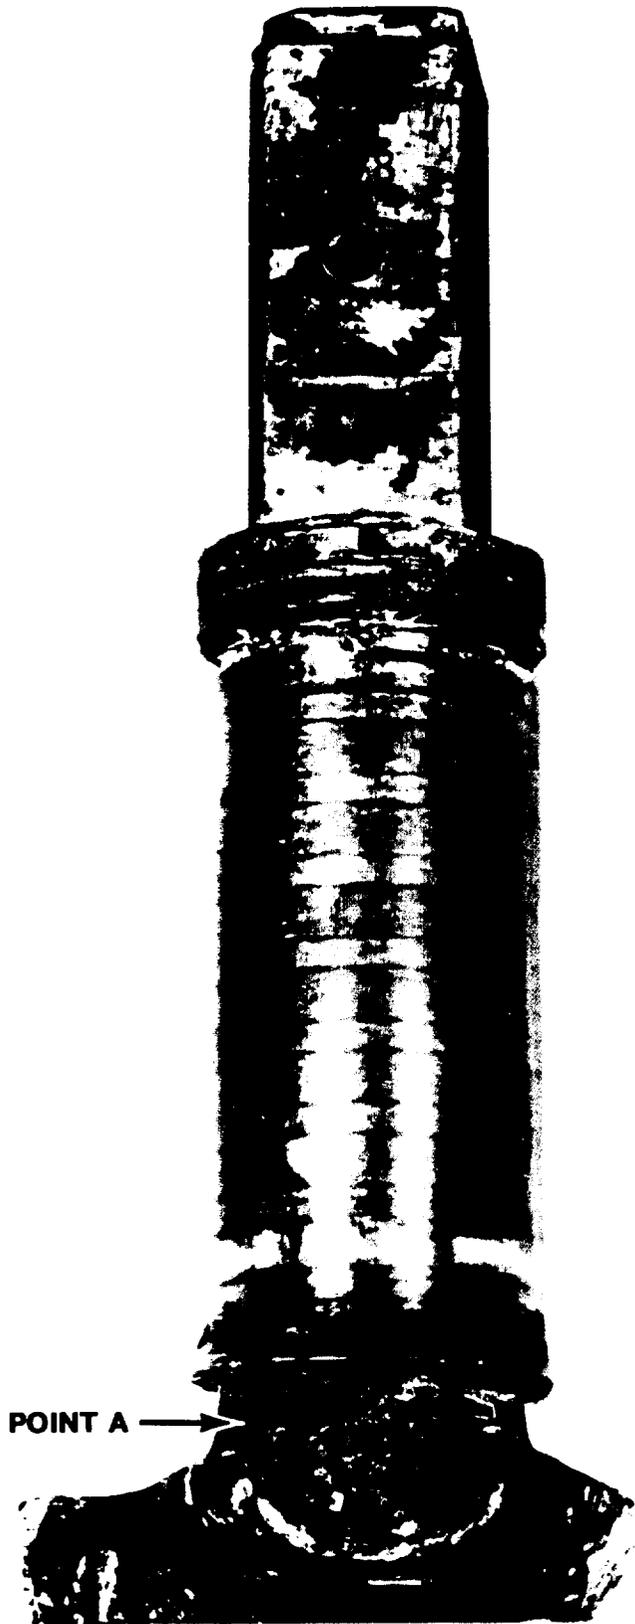
**8.05** Some cells examined will have a black butyl adhesive material on the lead post, and on or under the epoxy (Fig. 9, Point D; Fig. 10, Point A; and Fig. 11, Point B). This butyl material should not be confused with post corrosion.

Fig. 10—Rating 1—With Butyl Adhesive

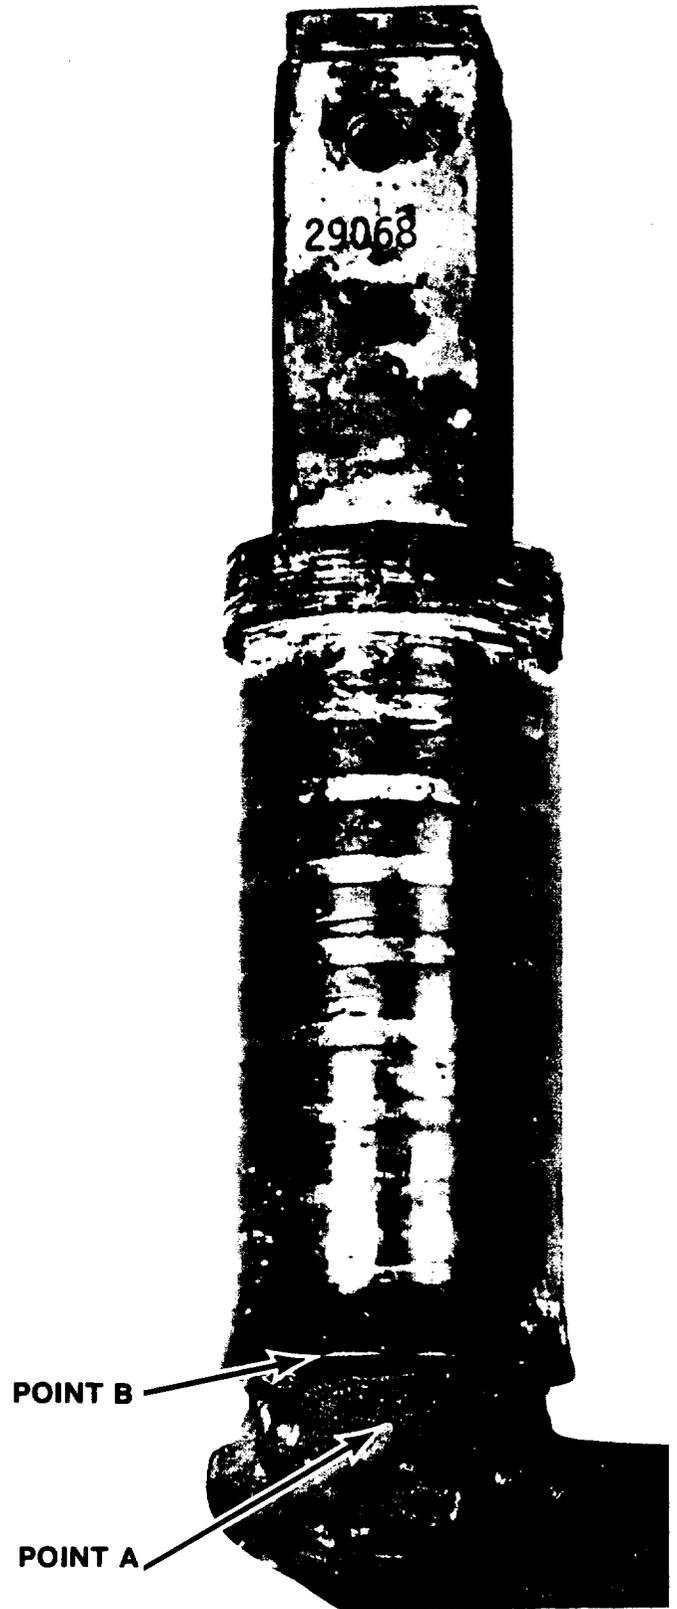
**8.08** The irregularity on the lead post (Fig. 11, Point A) and on the lower edge of the epoxy (Fig. 12, Point A) should not be confused with post corrosion.

Fig. 11—Rating 1—With Butyl Adhesive Under Epoxy

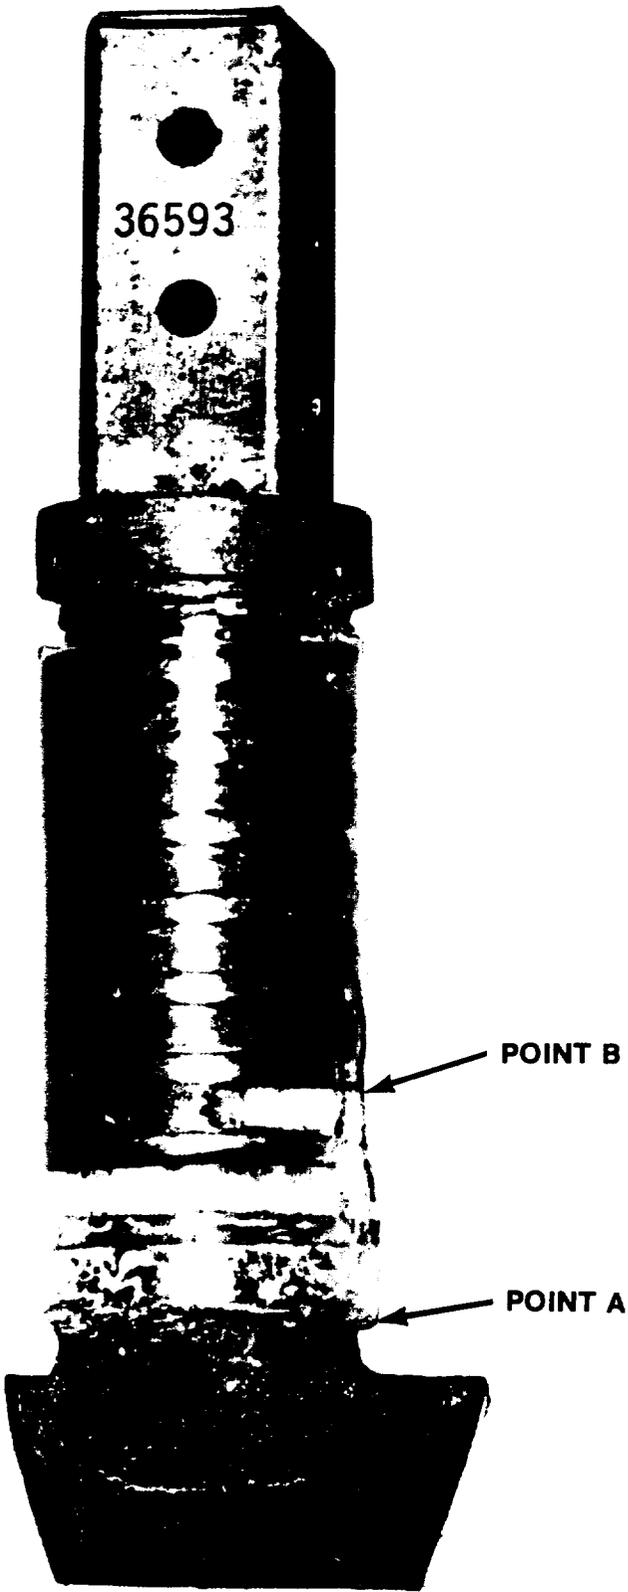
Fig. 12—Rating 1—With Distorted Epoxy

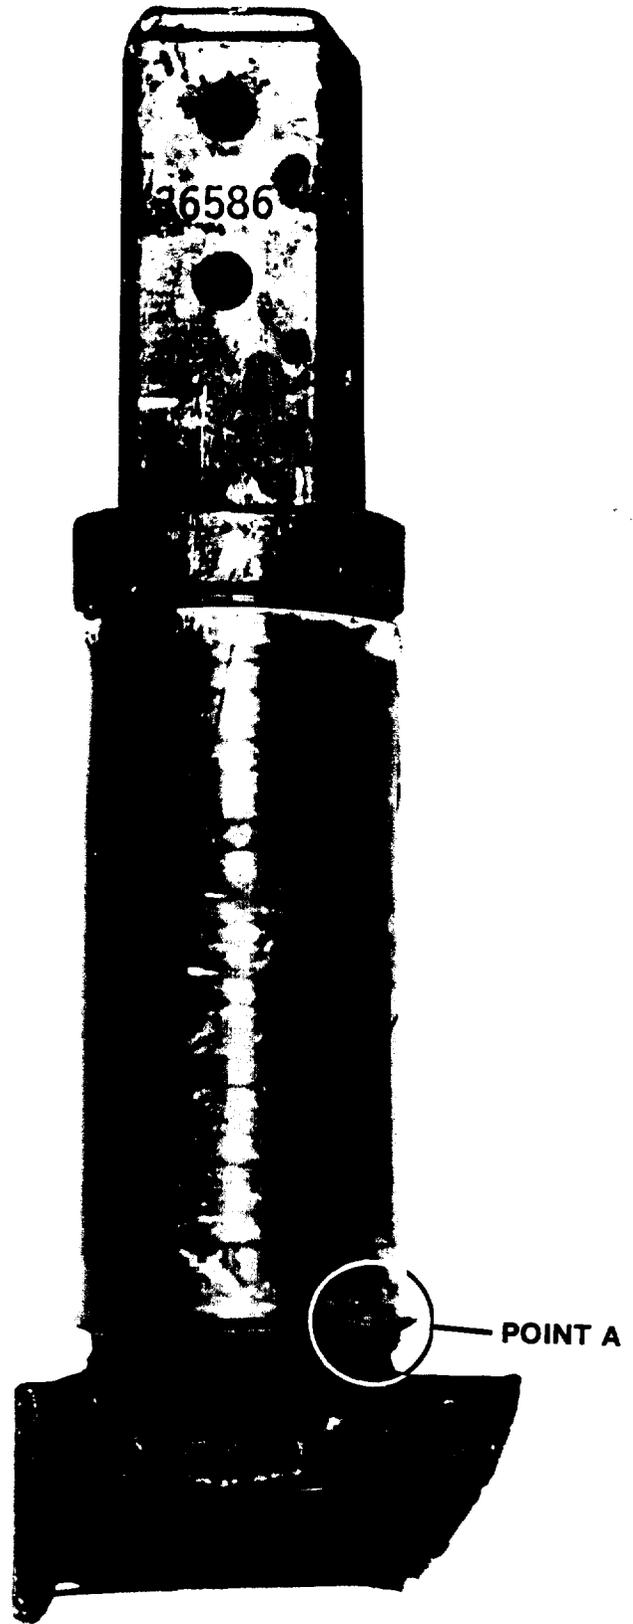
(f) Swelling centered at edge of epoxy (approximately 1/8-inch high, 1/2-inch diameter)	Fig. 13, Point A
4	(a) Epoxy cracked, caused by corrosion at Point B on Fig. 18 and 20	Fig. 18, Point D Fig. 20, Point A

Fig. 13—Rating 3—Swelling at Edge of Epoxy

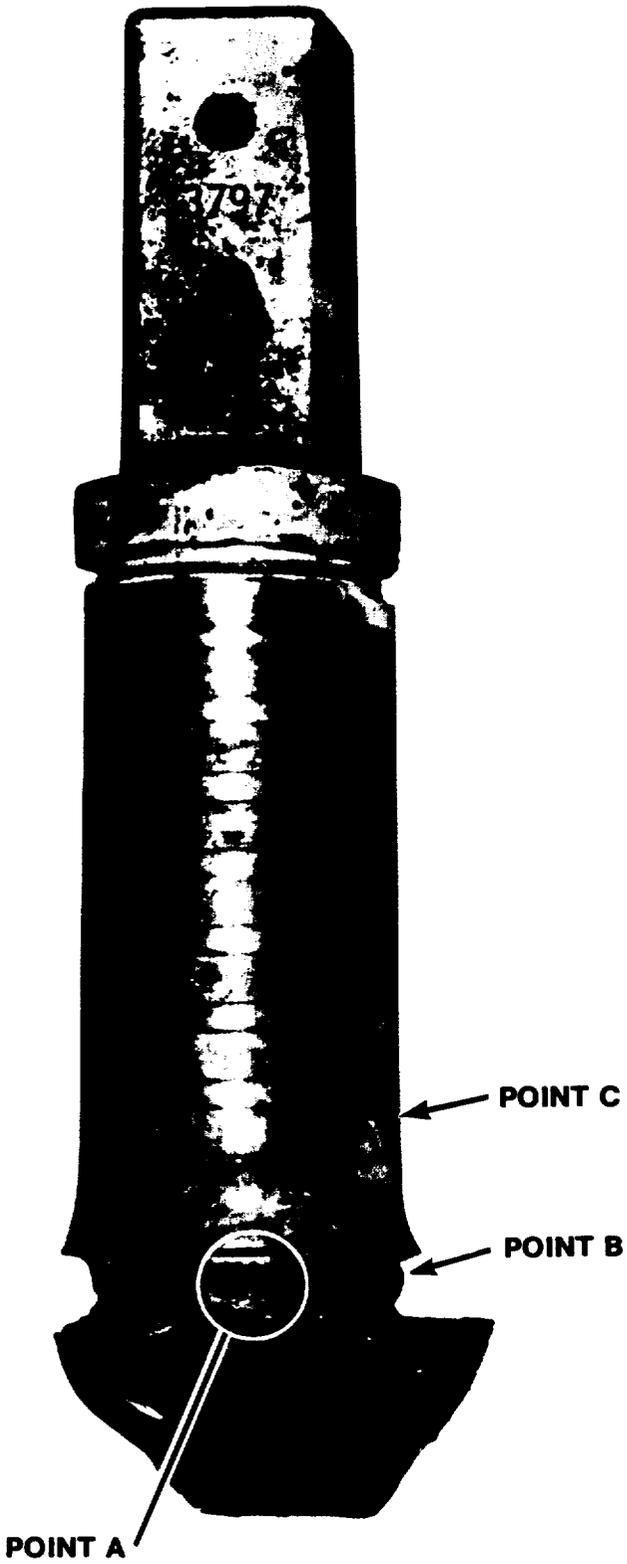
(b) Slight pullaway of epoxy from lead surface	—
3	(a) Blisters or swelling visible on lead (greater than 1/8-inch diameter)	Fig. 15, Point B
	(b) Small to medium size eruptions on lead	Fig. 15, Point A Fig. 18, Points A and C

Fig. 15—Rating 3—With Two Corrosion Sites

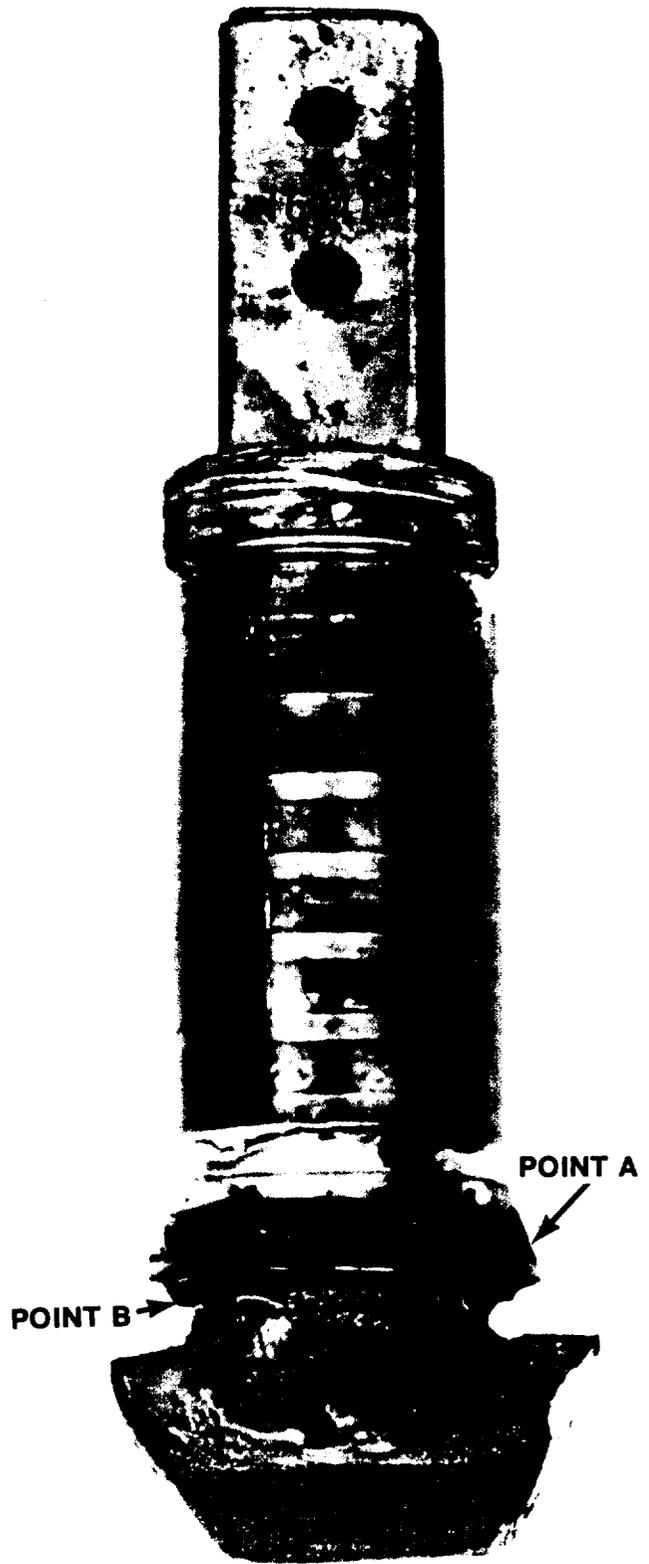
(c) Worst case of Class 3 type eruption	Fig. 17, Point A
	(d) Medium degree of flaring or pullaway of epoxy at the bottom edge of the epoxy column	Fig. 16, Points A and B

Fig. 16—Rating 3—With Epoxy Flare

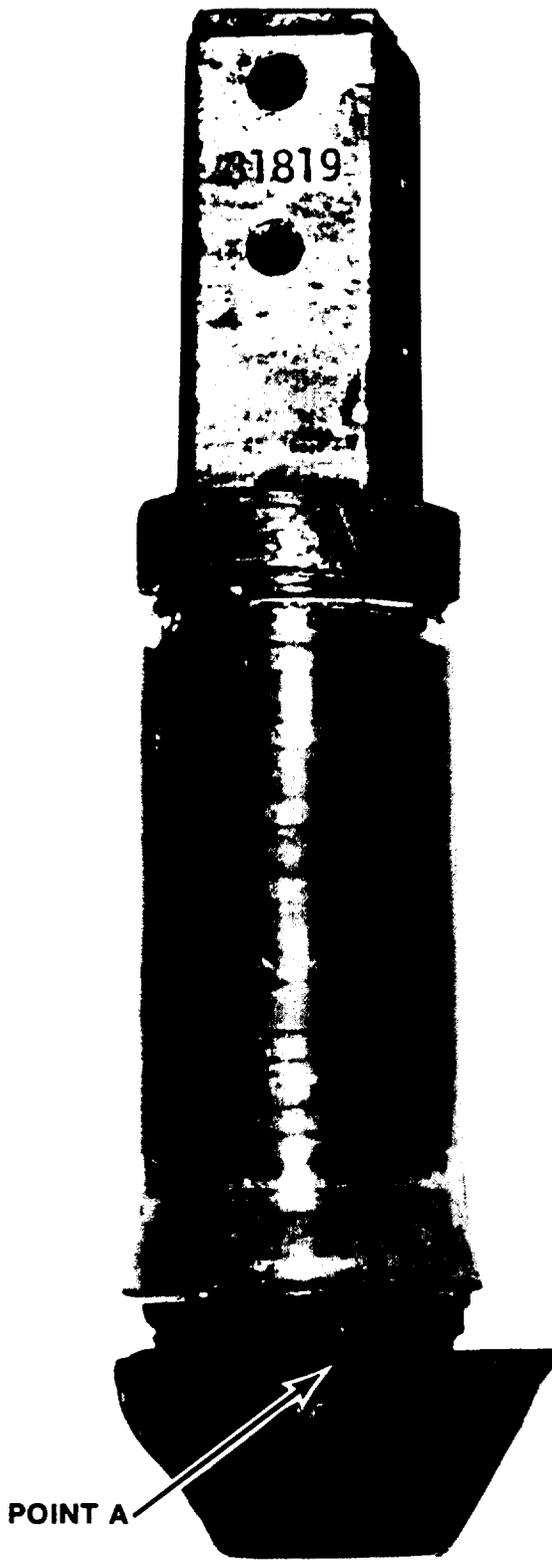
Fig. 17—Rating 3—Worst Case

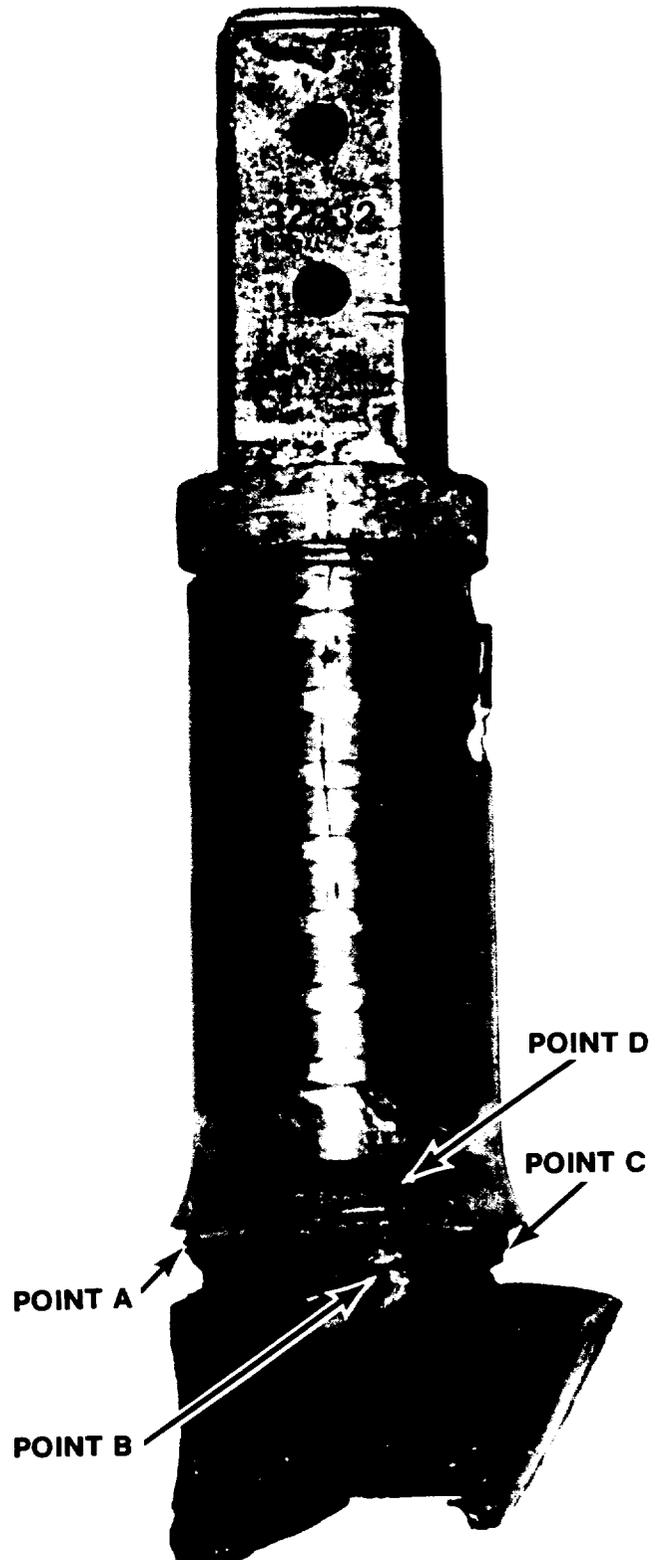
Fig. 18—Rating 4—Typical

6.01 Place a defective cell label on all defective Class 4 and 5 cells (see Fig. 3). An Engineering Complaint should be filed to obtain replacement of all Class 4 and 5 cells. Copies of the replacement Visual Inspection Report Form should be attached to the Engineering Complaint.

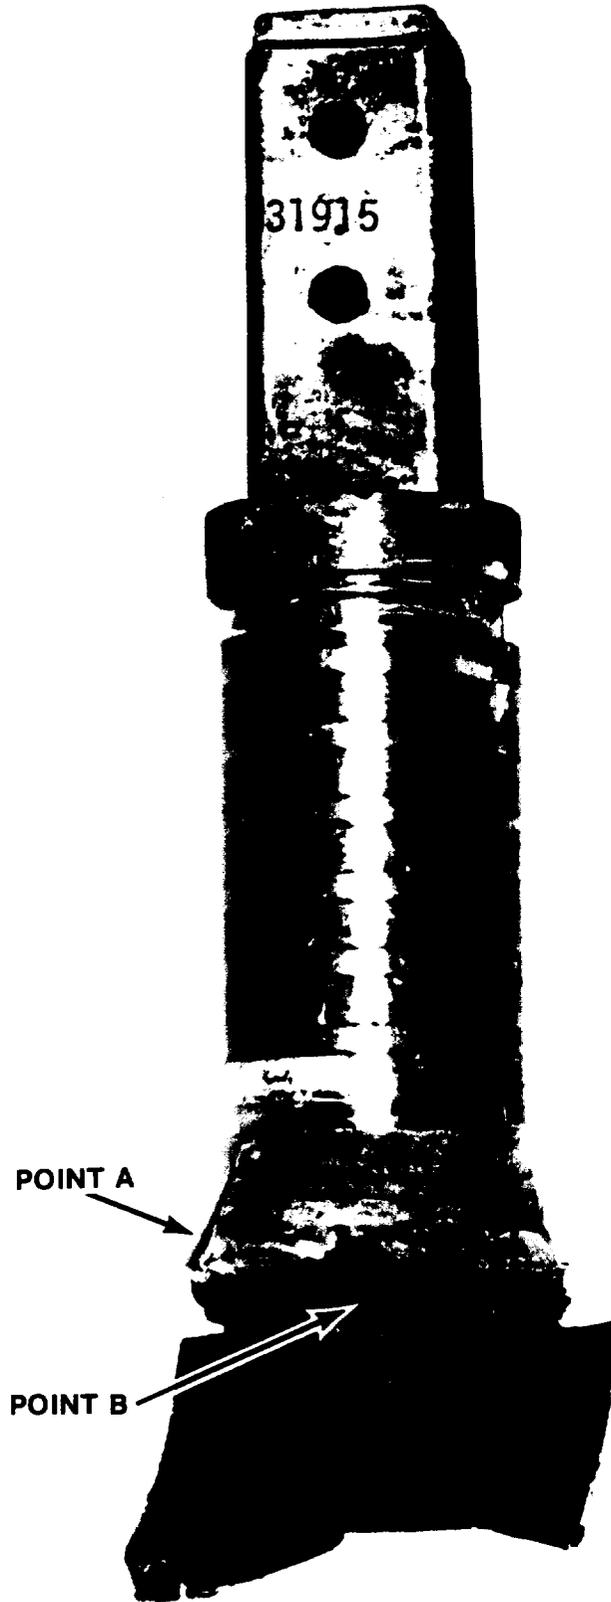
(c) Large portion of lead post is corroded	Fig. 20, Point B
	(d) Corrosion has progressed into post to a depth of 3/8-inch or greater	—

Fig. 20—Rating 5—Typical
