A major responsibility of the Bell System is the safeguarding of telephone customers from electric shock and fire hazards. This is achieved by the use of protective devices throughout the telephone plant. Recently, Bell Laboratories has developed, for open-wire lines, an improved protector to limit voltages that may arise from accidental contact with electric power wires.

A. E. Dietz and J. B. Hays

A New Protector for Telephone Lines

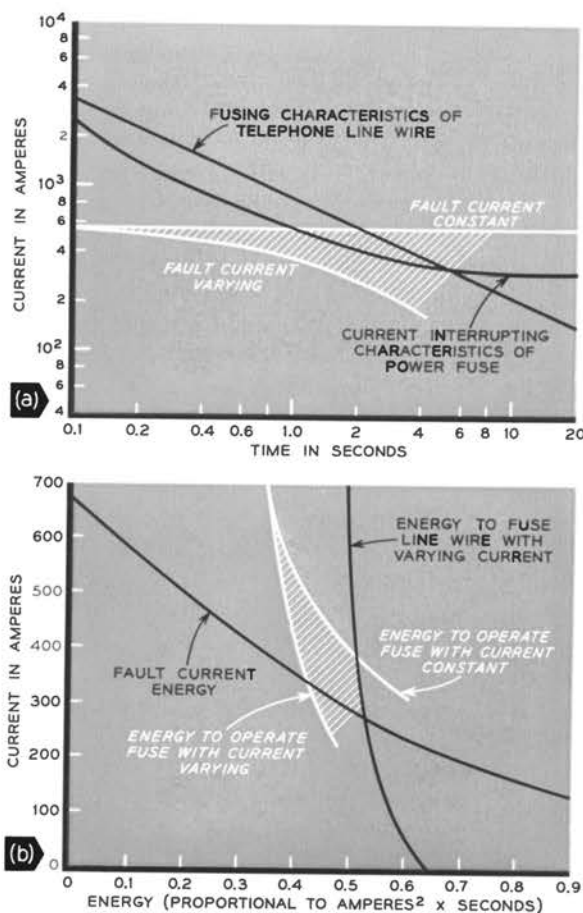
Typical graphic methods that determine what value of fault current will operate power-interrupting device. Fuse and line-wire characteristics are related to (a) fault current, and (b) energy.

These difficulties can be appreciated by examining the curve of changing current for a specific situation shown as the dashed line in part (a) of the illustration at the right. Here, the initial current is nearly 700 amperes. After 0.16 second, the wire has heated; this changes the resistance by 25 per cent. Recalculation at this time thus yields a new value for the current, and successive calculations result in the curve of dynamic current. Basically, these plots are made to see whether the current will operate the power-interrupting device and if so, whether the current will operate the device before it reaches a value that can fuse the wires or damage the protector. In this particular curve the power-interruption device would not be operated. In addition, tests were made to determine that the protector would not be damaged before the wire fuses.

In a sense, a contest exists between the fusing of the wire and the operation of the power interrupting device. The curves in part (a) of the figure showing these characteristics are correct, however, only for constant fault current since

By another graphical maneuver, we can convert the time scale to an energy scale and replot the curves to show cumulative energy. When this is done, as in part (b) of the illustration, we see that the dynamic curve of energy delivered (the black diagonal line) by the varying fault current intersects the power-fuse boundary before it reaches the wire-fusing boundary; thus, the fuse will operate first. If this were not the case, it would be necessary to reduce the spacing of the protectors along the telephone line so that there would be a smaller length of telephone line in the fault-current path, and thus less change in the current with time.

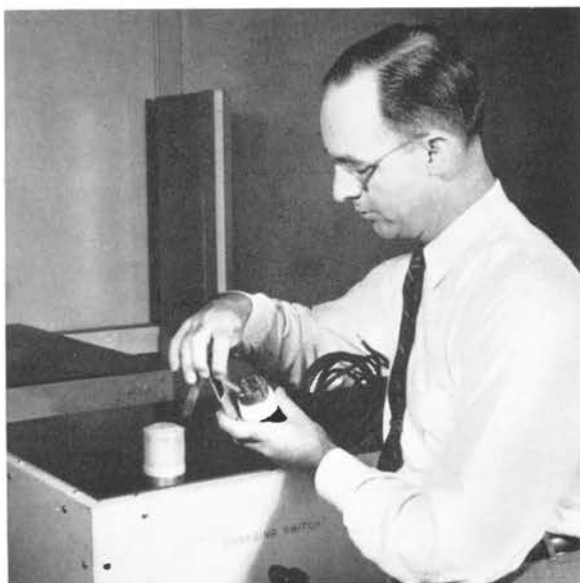
J. B. Hays checks spacing of carbon blocks on the 118A protector. Gap of 0.02 inch arcs at 2000 volts.

the former device in the shape of its electrodes. The new electrodes, spaced 0.02 inch apart, have flat, rather than cylindrical arcing surfaces. This allows the arc to take place over a very large area. An increase in arcing area results in less erosion of the electrode material, and consequently in a smaller increase in the breakdown voltage on sustained faults.
