The Chester Laboratory

The open-air laboratory at Chester, N.J., is geared for practical analysis of telephone equipment prior to Bell System introduction. Installation, operating, and maintenance procedures can be evaluated under realistic field conditions.

ROBERT W. BLACKMORE

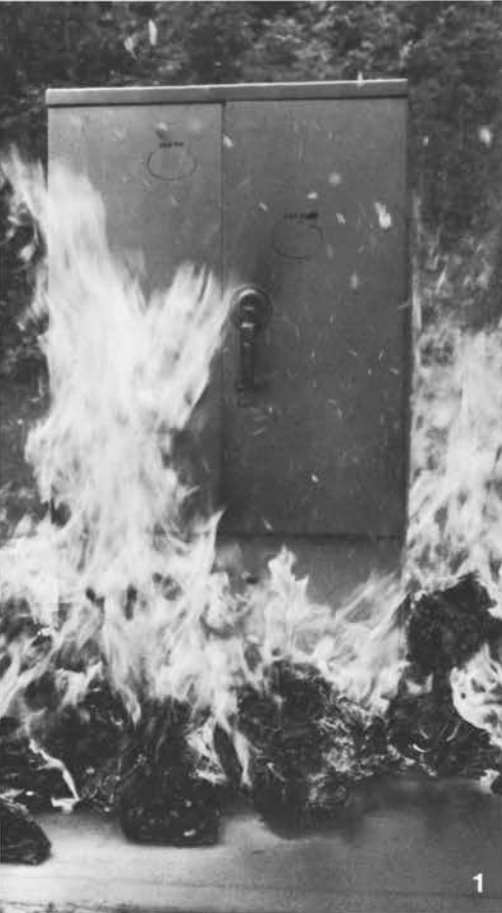
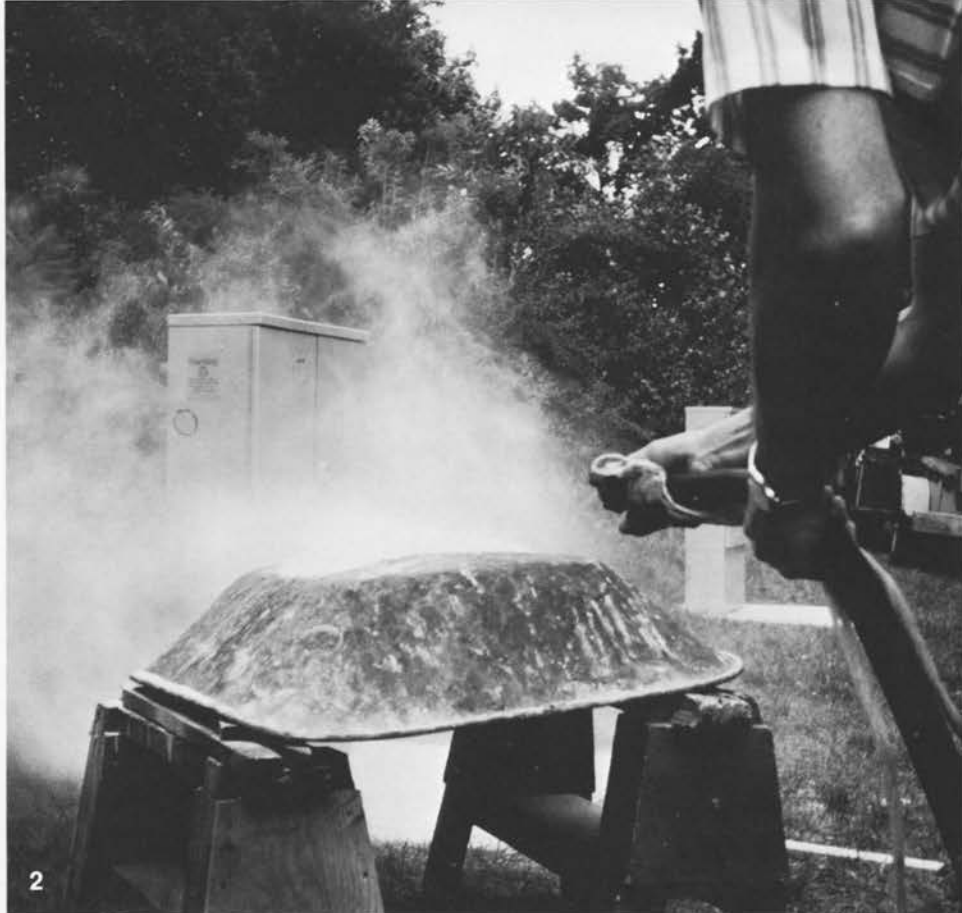
Stress. The Rural Area Interface (RAI) terminal for rural telephone networks was subjected to many grueling tests at Chester, among them: (1) simulated brush fire, (2) simulated wind-blown dust, (3) immersion in a

pond to simulate severe water exposure. Tests such as these help to assure the designers that the equipment will withstand severe field conditions, and indicate where improvement may be needed.

The stress phase of the construction evaluation included forcing cabinet entry with a screwdriver, and using excessive seating force on the 88-type connector blocks both at normal ambient temperature and at 30°F as well. To evaluate the corrosion and insulation-resistance problems that would be caused by a severe water exposure, one partially terminated unit was submerged in a pond for 72 hours and then left outdoors for three weeks with the doors open. Paint adhesion and insulation-resistance tests were made following this severe exposure.

The operational evaluation included investigations of weather-induced environmental effects, of the effects that are unique to the rural environment, and of the effects of concentrated (or accelerated) craft activity at the RAI unit. The effects of wind-driven rain and dust were simulated on open and closed cabinets with water and air hoses. These exposures were followed by tests of the insulation resistance and dielectric strength of the working circuits. Rural-environment exposures included subjecting the cabinet to pick and shovel blows, a simulated brush fire, and shots fired from a rifle and shotgun at various ranges (such things do occur). The stability of the unit on its base was evaluated by means of graduated impacts from a suspended 100-pound sandbag swung in a vertical arc.

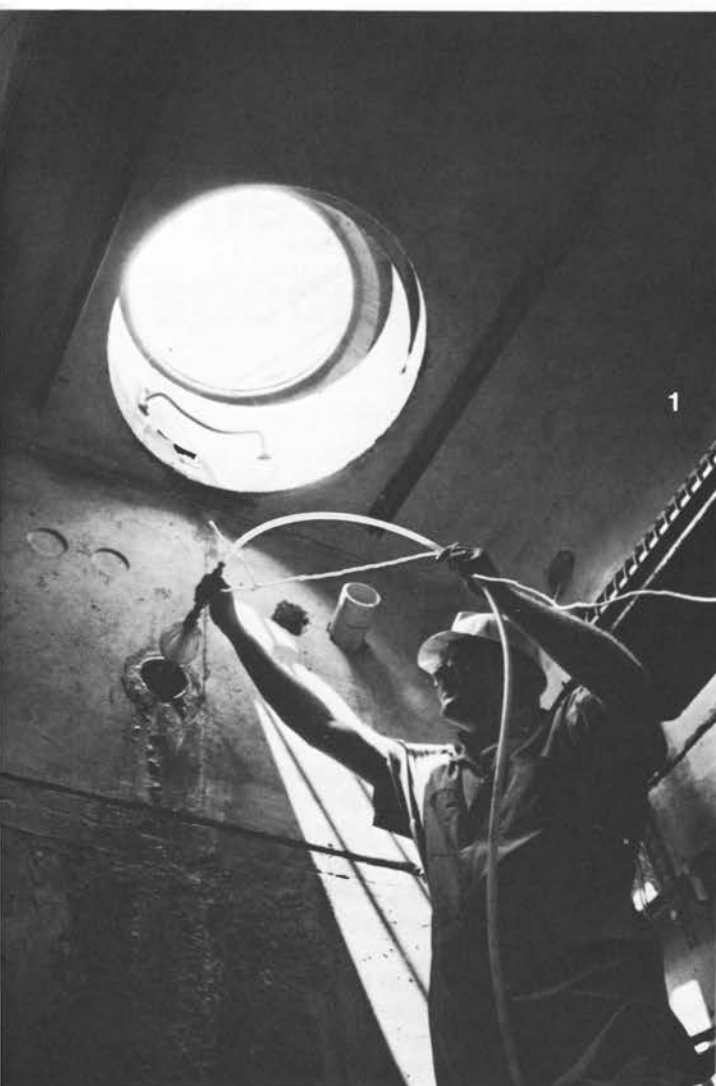
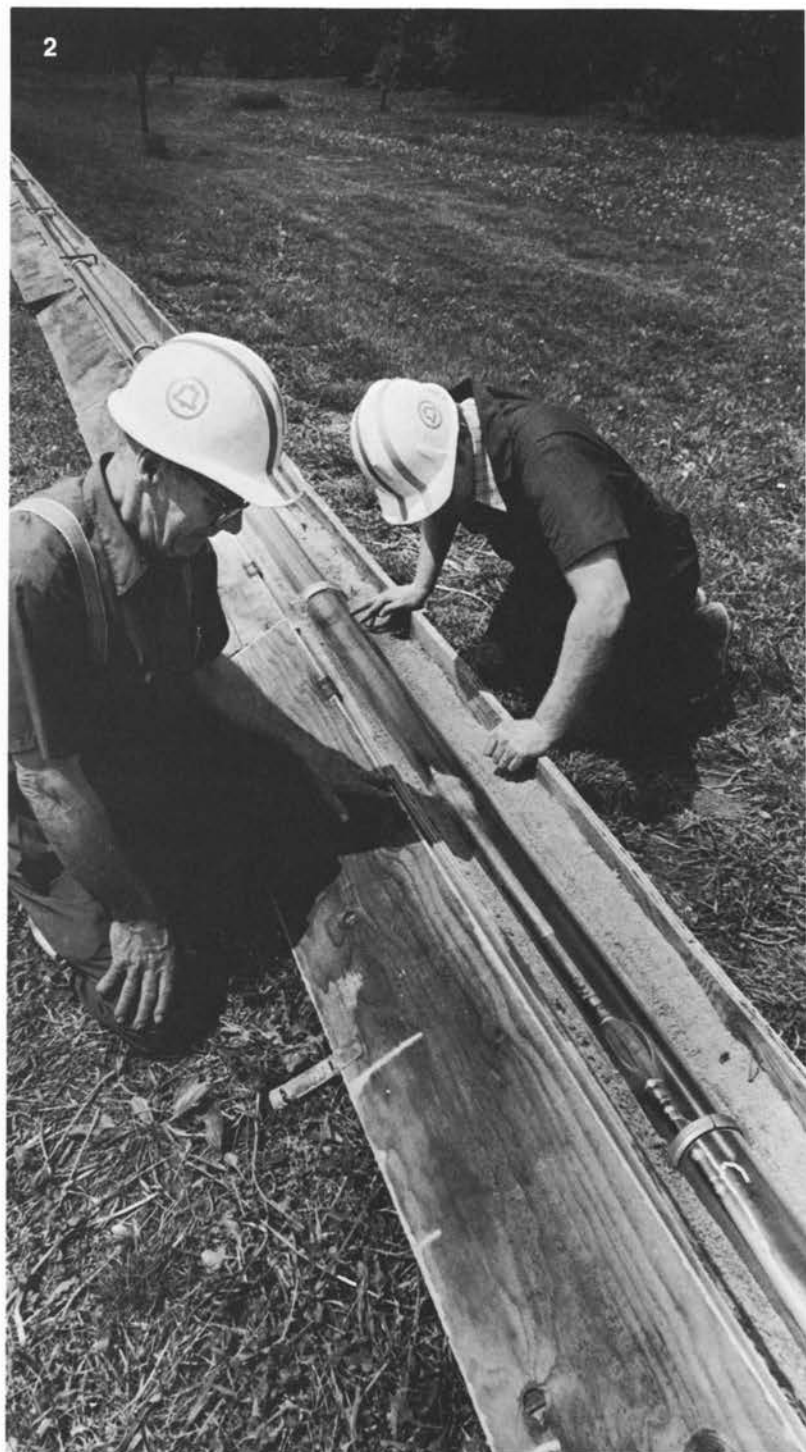
See-through. Chester people evaluate the performance of a "duct motor," a device that pulls a rodding line through a duct, the first step in installing cable in the duct. (1) Dave Gibson inserts the duct motor from a manhole. (2) Frank Fentzlaff (left) and Gibson observe the progress of the motor through a transparent duct,

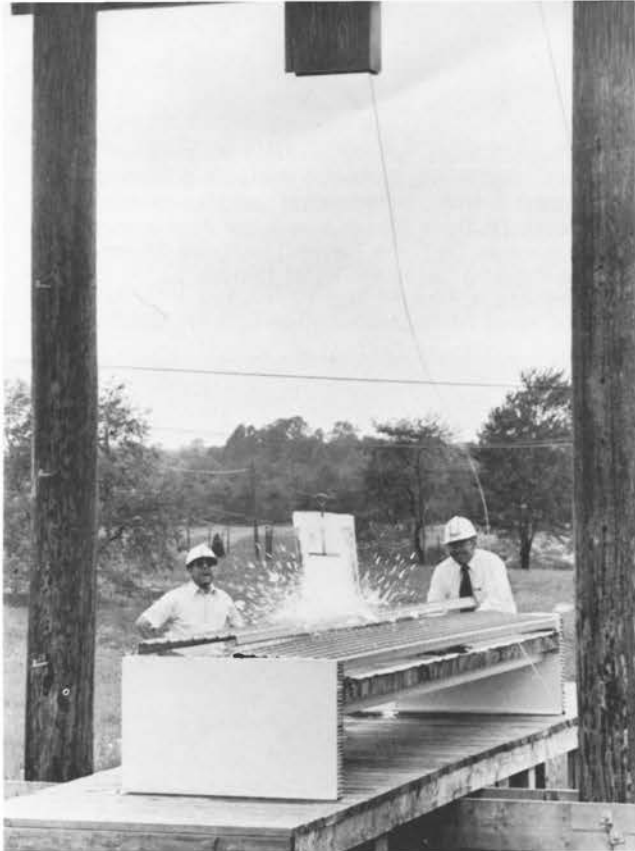
Falling ice. A block of ice falls 50 feet onto a prototype roof shield, as Vinnie Di Lullo (left) and Don Graupner conduct a test to evaluate the shield's effectiveness in protecting repeater huts from ice falling from microwave antenna structures.

- In the Telephone Buildings and Equipment area, evaluations will be conducted on bracing systems designed to bolster telephone equipment frames against earthquake shocks. Full-scale sections of roof systems and shields developed to protect microwave repeater huts from ice accumulations falling from antenna structures will also be tested.
- New designs for undersea cables and associated couplings will be subjected to tensile loading typical of cable laying operations.
- The recently enlarged high-voltage facility will be used to evaluate the electrical safety and protection aspects of all types of telephone apparatus and equipment, ranging from that in the central office to that on customers' premises.
