## KS-20472 BELLCELL\* BATTERY VISUAL INSPECTION PROCEDURE

**SECTION 157-629-702**

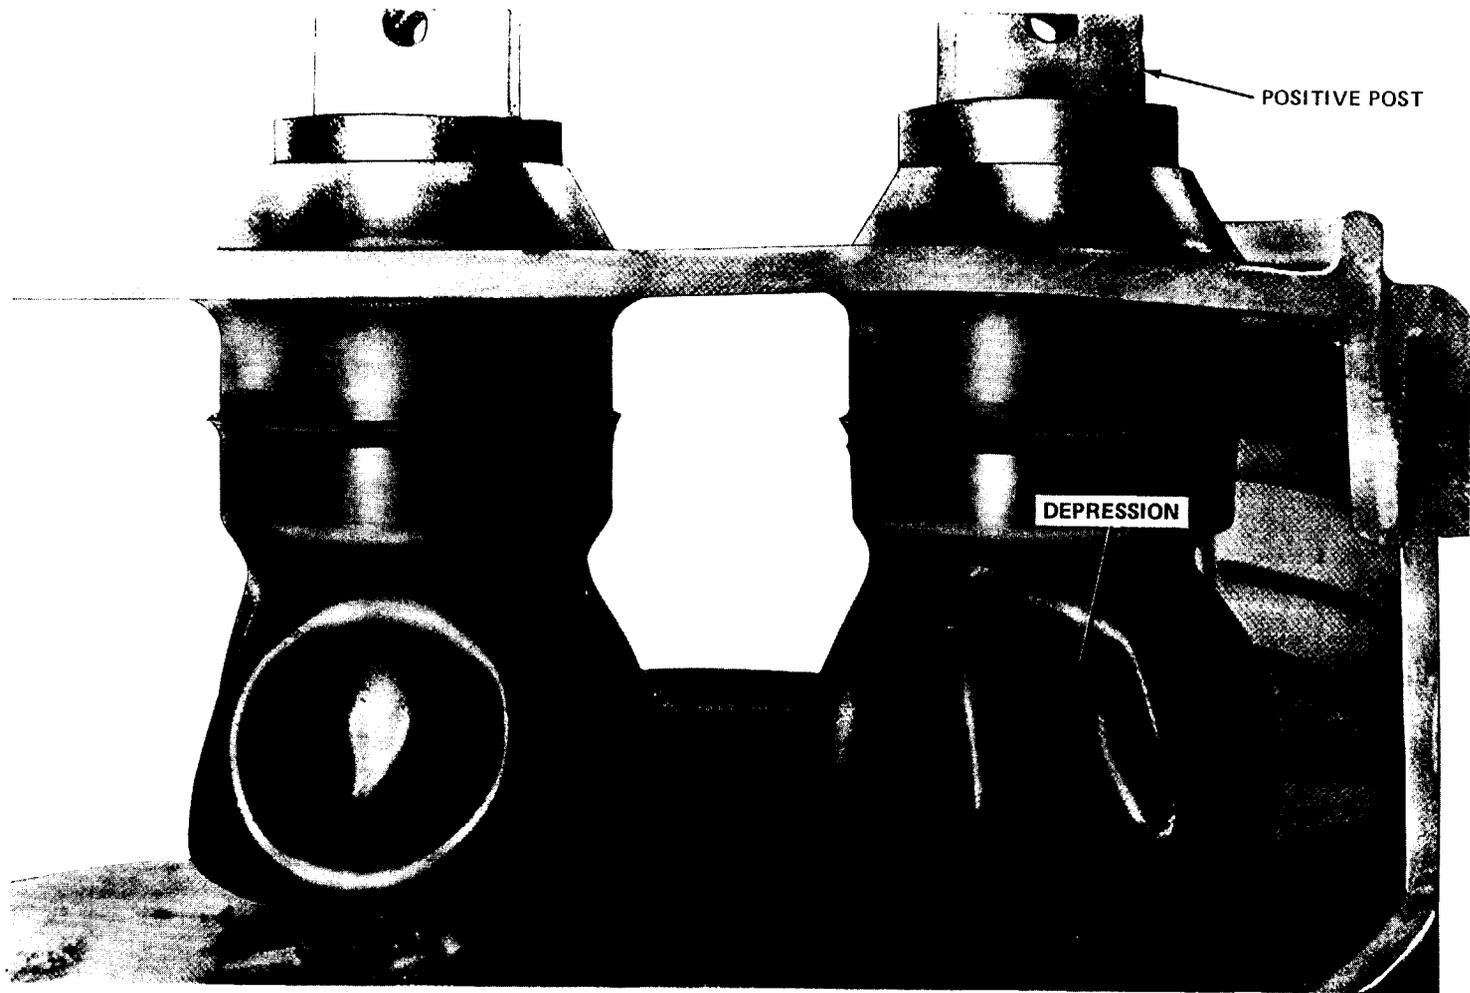
Fig. 6—Cell Post Boots Showing Normal Depression

4.03 As the corrosion increases, broken particles and powder can start to fill up the boot. Techniques for assembling the post seals in manufacture are such that the boot section of the rubber sleeve will usually have depressions in it. These depressions are shown in Fig. 6. On positive posts, with severely defective seals, the accumulation of corrosion product expands the rubber boot such that the depressions disappear. This is shown in Fig. 7 where no depressions exist in the boot of the positive post seal. Depressions still exist in the negative post boot since corrosion does not occur on the negative post. Sometimes the boot section is inflated because of air pressure inside the boot. Accordingly, it is necessary to probe the boot with the tip of the hook in order to differentiate between corrosion and air. If air fills the boot, it will be flexible. If corrosion fills the boot, it will be hard and should not be lifted.
