## TELEPHONE SETS — 5300 SERIES

### MAINTENANCE

This section covers the maintenance of 5300 series telephone sets and is reissued to correct Fig. 3.

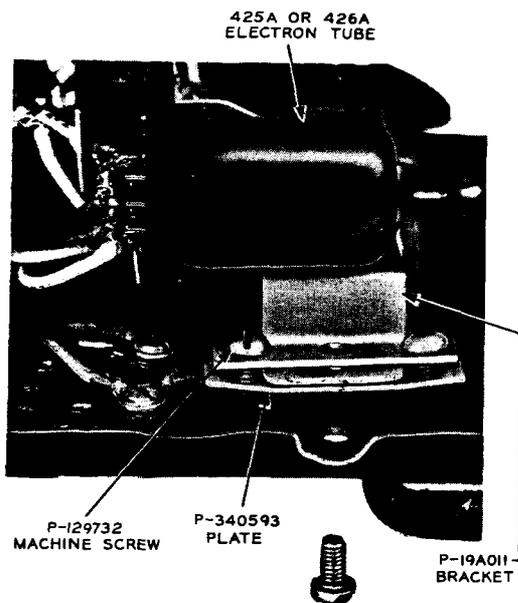
When replacing or rearranging the mounting cord, remove the electron tube from the bracket to facilitate terminating the R and GND conductors.

Fig. 1 — Electron Tube and Bracket

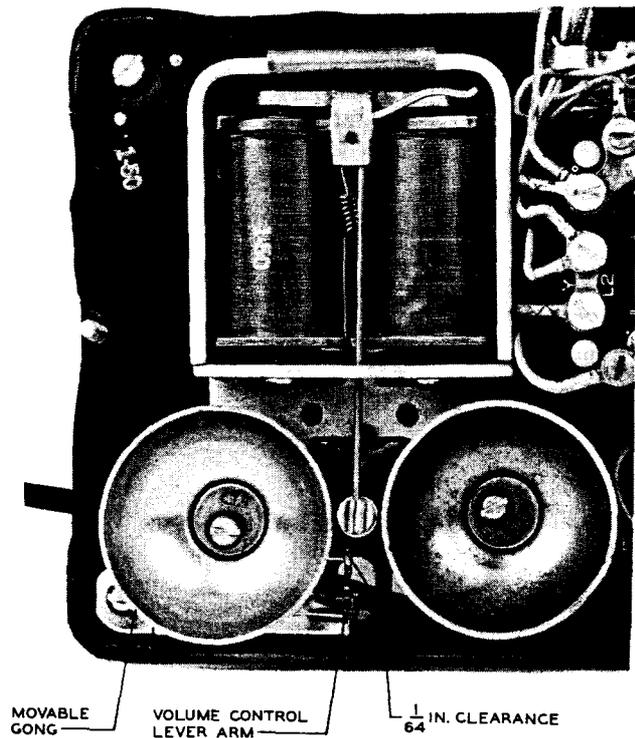
4.01 With the ringer volume control in the low volume position (the lever arm towards the edge of the set) and the gong in place on the volume control bracket, there shall be a clearance of at least  $\frac{1}{64}$  inch between the gong and the clapper. The clapper shall be centrally located between the sides of both gongs. Gauge visually.

**Note:** For this adjustment, the ringer bias spring shall be in the center position.

Fig. 2 — Ringer Gong Adjustment

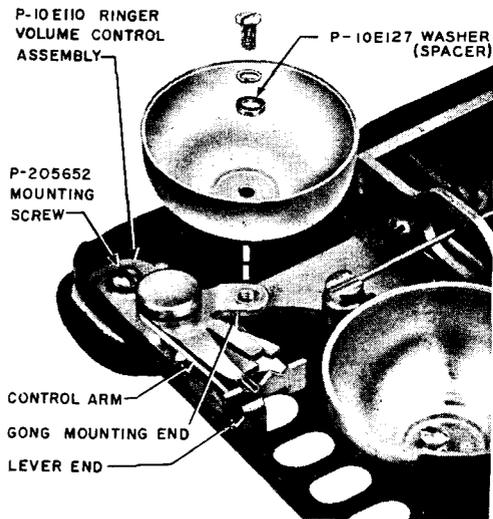
4.02 The ringer volume control assembly must be removed in order to replace the ringer.

Note: On 5306C sets, washer P-10E127 is not required.

Fig. 3 — Ringer Volume Control Assembly

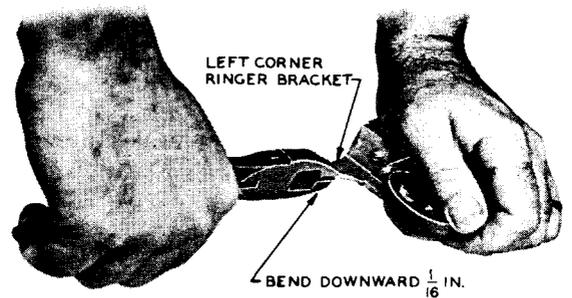
When replacing ringer, make certain that clearance is provided for operation of left ringer

gong through its three positions on the ringer volume control assembly. If this clearance is not obtained, it will be necessary to bend the left ear of ringer bracket downward approximately 1/16 inch, using pliers as shown in Fig. 4.

Fig. 4 — Method of Bending Left Ear of Ringer Bracket
