COMMON SERVICES RACK WIRING U.A.X. N.Z. 13R			
NZ. NOTE A WAS NOTE 1	(72552)	1B	2.4.64 Dgk
NZ. NOTE A ADDED	(48005)	1A	2.11.61 Dgk
	(34727)	1	17.12.54 Cud
AMENDMENT PARTICULARS	ISSUE DATE	APP	SIZE L 50V G
N.Z.P.O.	AM	13.1.64	GBW. 13700

COMMON SERVICES			
RACK WIRING			
U.A.X. N.Z. 13 R			
AMENDMENT PARTICULARS		ISSUE DATE	APP'D
NZ NOTE A REF WAS NZ NOTE 1 (72552)		18/22/64	DBH
NZ NOTE 1 REF ADDED (48005)		2/11/61	DBH
(34727)		17/12/56	DBH
SIZE		50%	
GBW 13700			
NZ POX	AM WS	SHEET 3 OF 5

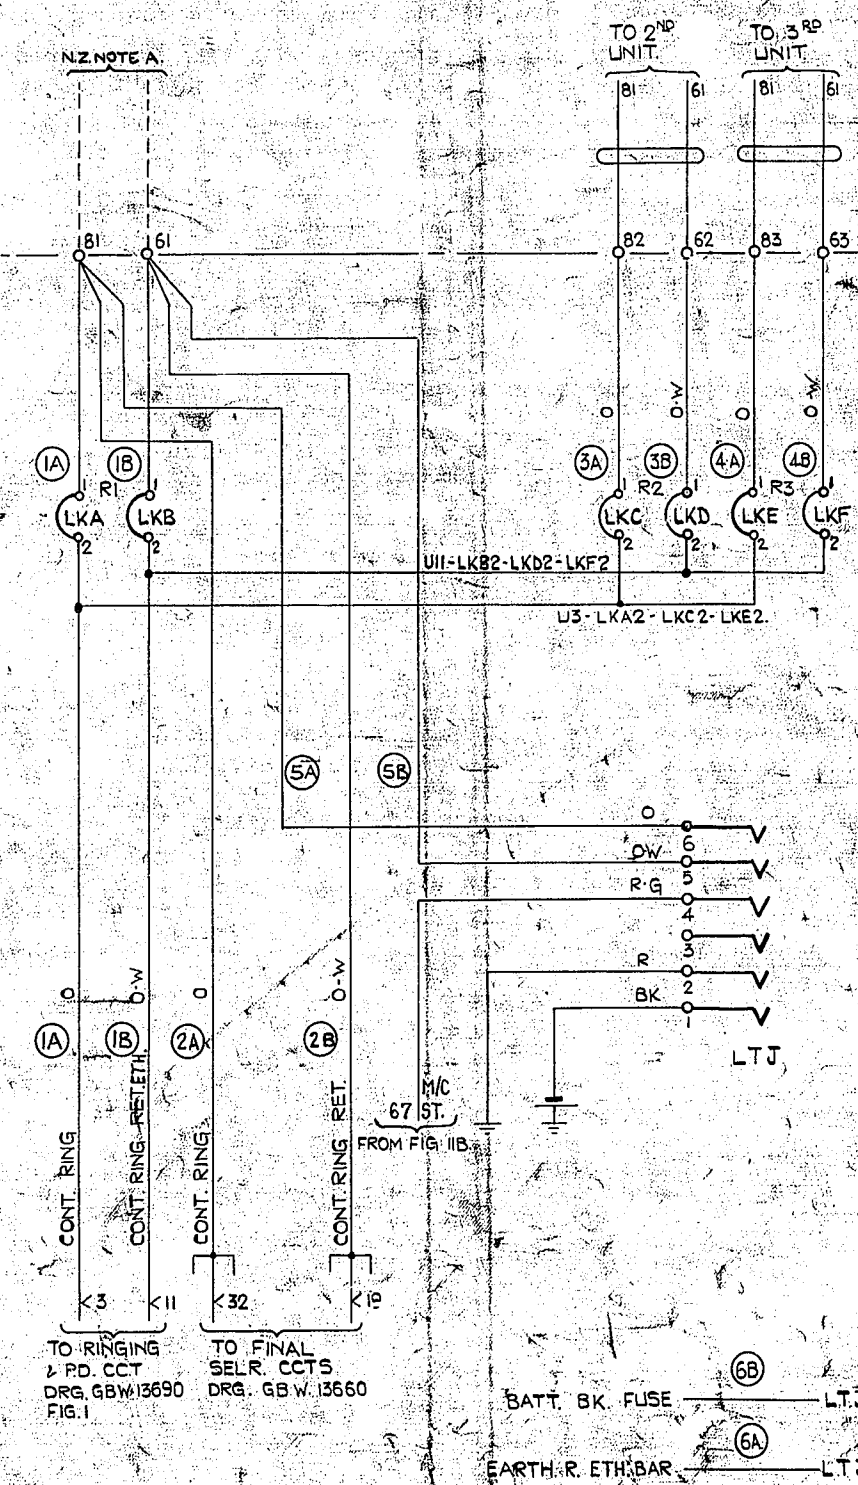
FIG. 9A CONTINUOUS RINGING & LINE TESTER JACK

FIG. 9B 1-PER RACK

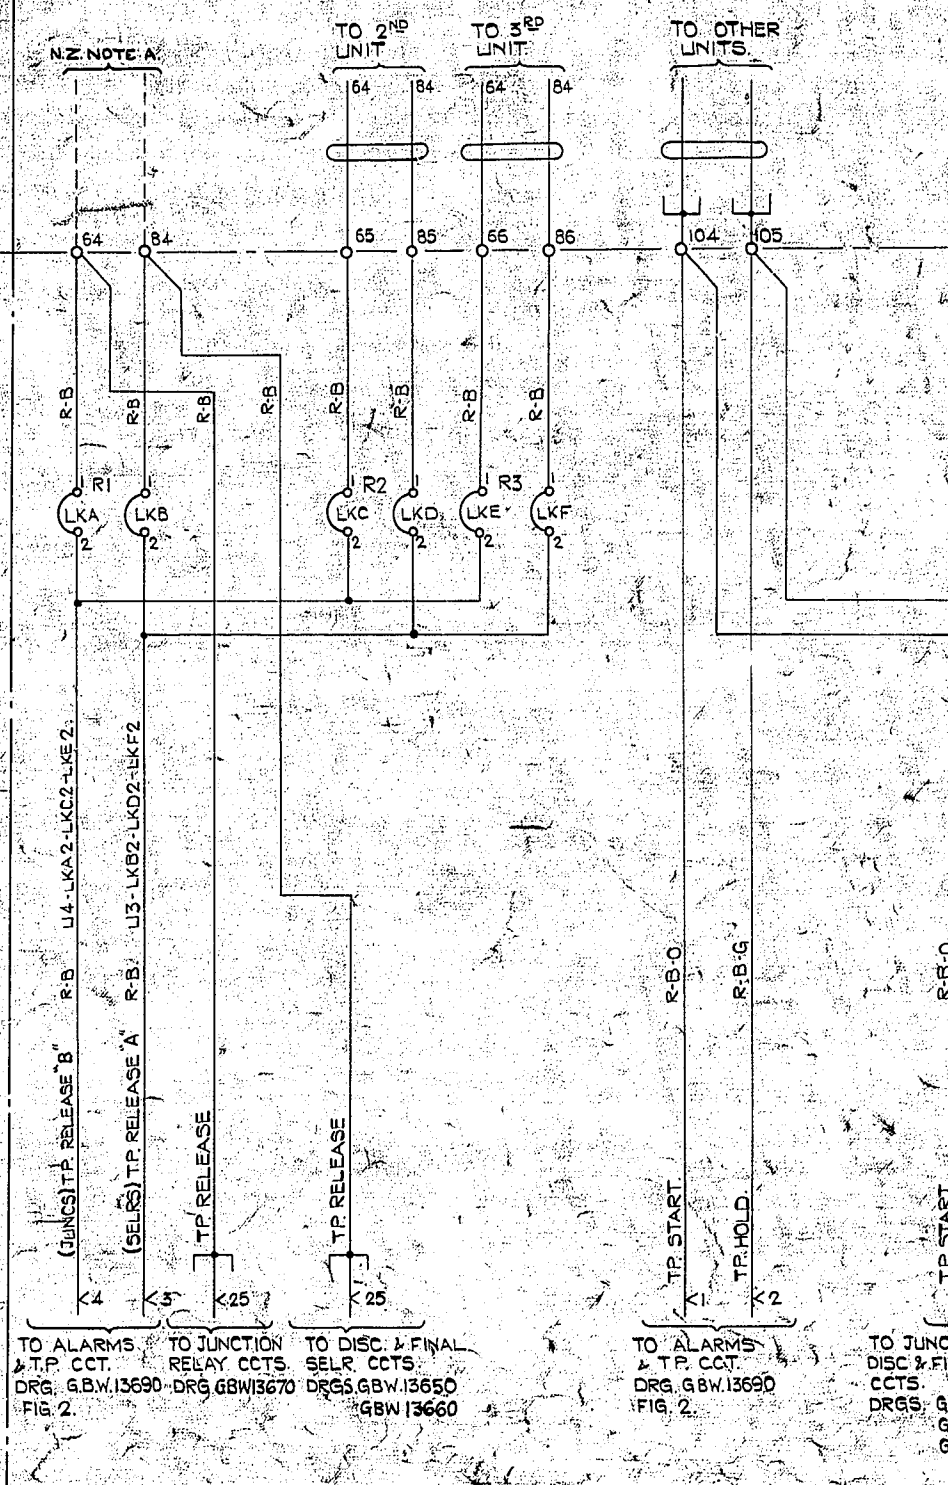
FIG. 10A TIME PULSE RELEASE

FIG. 10B 1-PER RACK

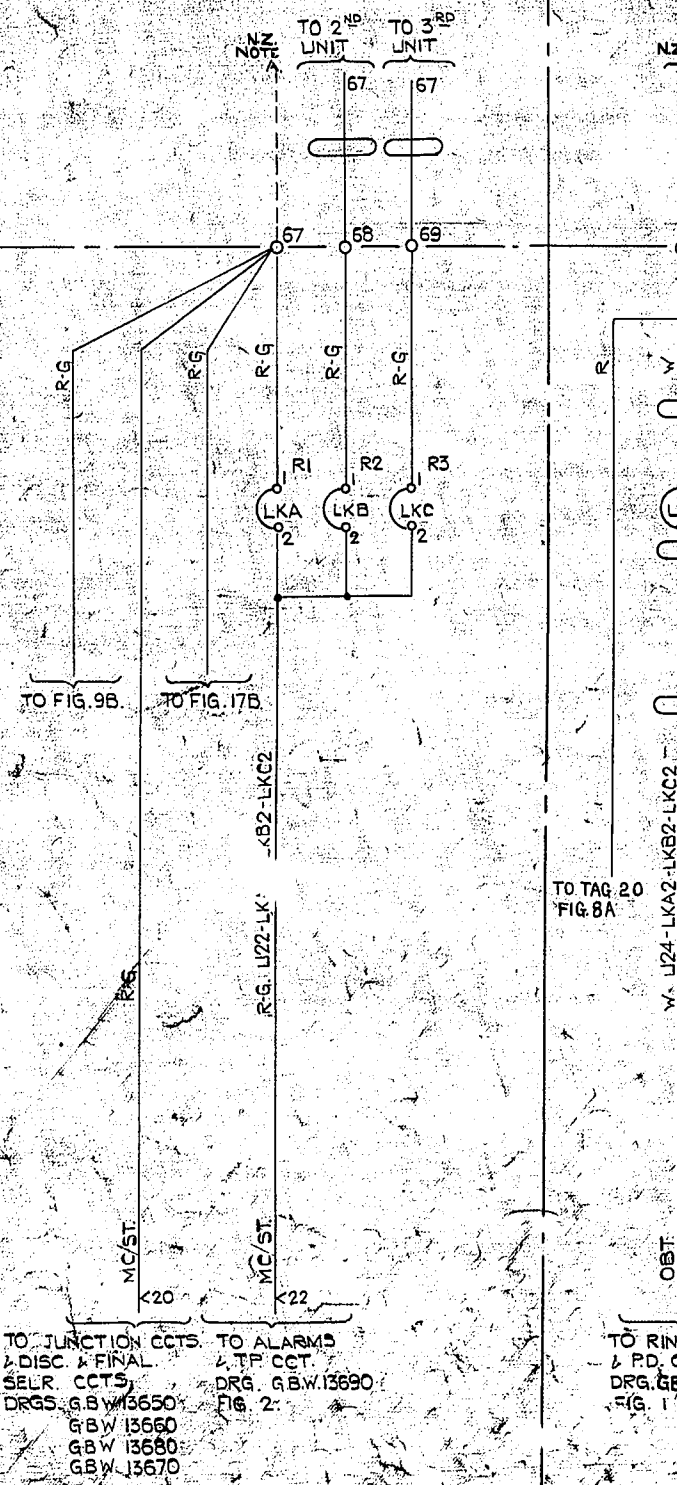
FIG. 11A MACHINE START

FIG. 11B 1-PER RACK

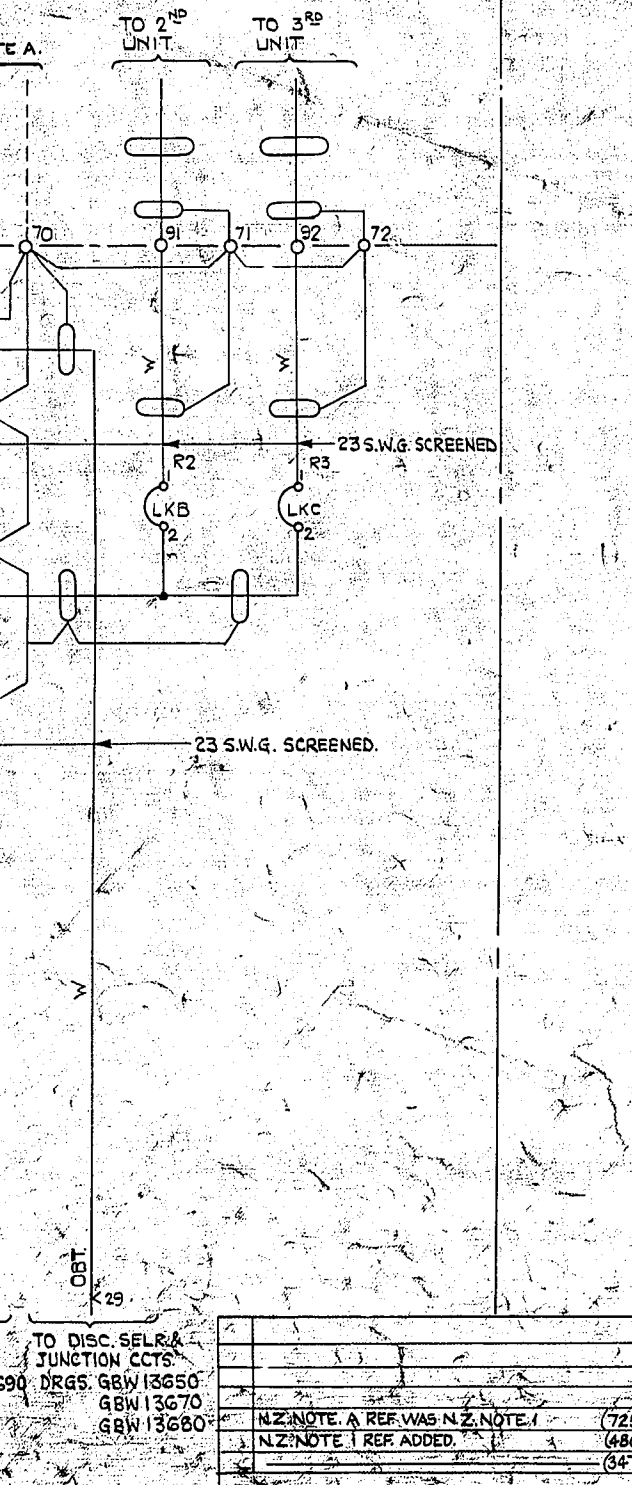
FIG. 12A OVERFLOW BUSY TONE - 900

FIG. 12B 1-PER RACK
